Slope Stability Analysis of Haibat Sultan Road Cut, Kurdistan Region, Iraq Using a Field Method

Abstract

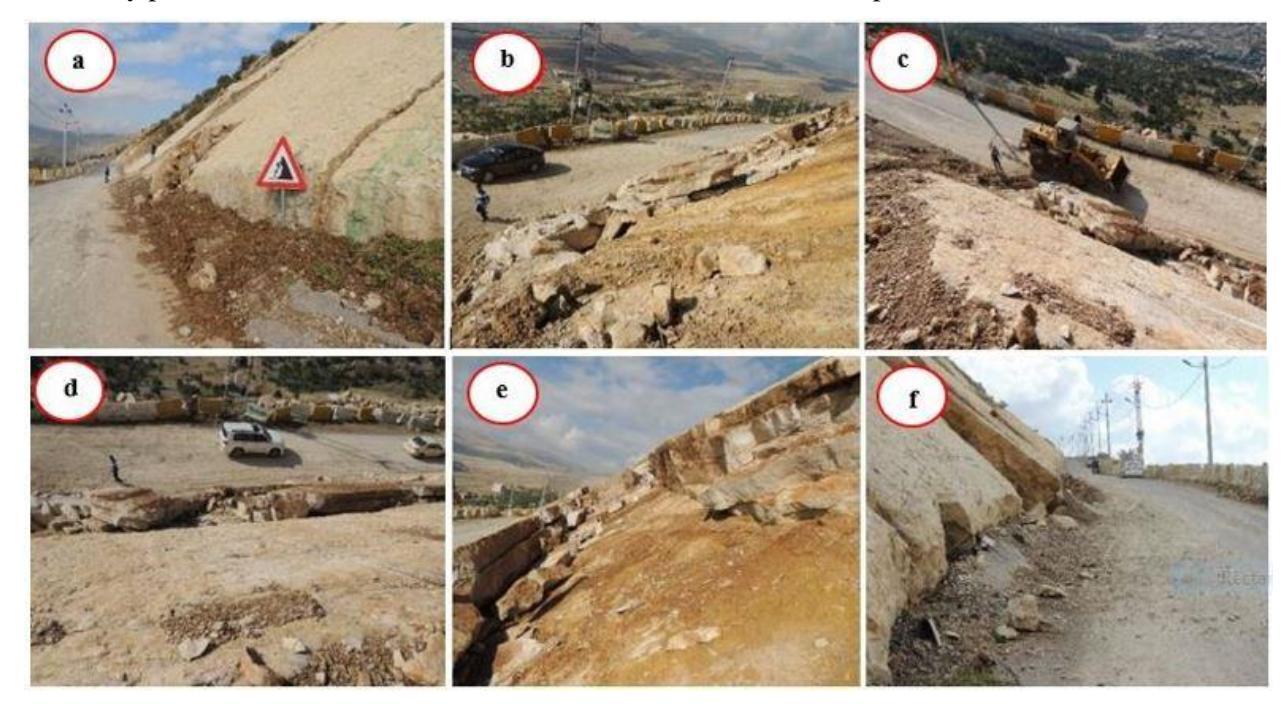
rain storm near studied station No. 7 where L.P.I. value of 28 was determined indicating Grade: VI, Category: Very High, Hazard Zone: High and Failure Possibility: Very High. On 11 November 2015, a large landslide (Fig. 3) had occurred at the same area, which is an excellent indication that the area is a potential area for slope failure and that the used Bejerman's method gives accurate data about the stability of the slopes on road cuts.

Fig. 3. Landslide of 11 November 2015 at Haibat Sultan Mountain. 3a) Traffic sign for rock falls indicating continuous landsliding, 3b) Large slid blocks, 3c) Top view of the landslide, 3d) Top view of the landslide, note the damaged road fence; in the back ground, 3e) The shear plane of sliding, 3f) Toe of the landslide, note the road had functioned as a retaining wall to stop the sliding of the rock blocks.

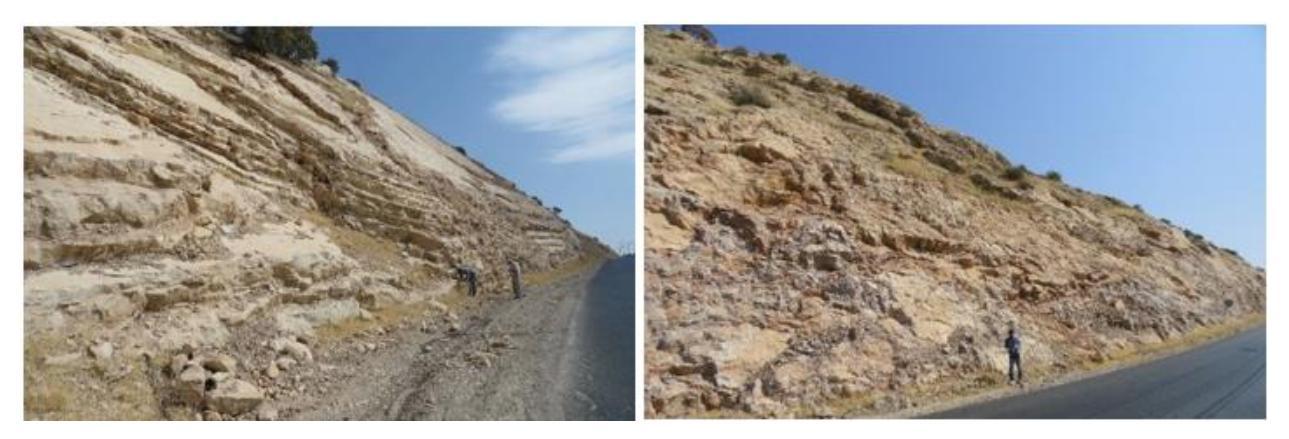
Sections A – B and B – C include studied stations No. 1 – 7 (Fig. 1). The main reasons for the presence of landslides and potential areas for sliding are: 1) The majority of the road cuts are parallel to the bedding planes of the Pila Spi Formation, where the bedding planes daylight in the slope faces (Figs. 3 and 4), 2) Locally, claystone and/ or residual clayey soil form potential areas for sliding (Studied stations No. 1 and 2) (Fig. 5), especially when oversaturated by rain water, which will increase the pore water pressure. This will decrease the internal friction and cause sliding (Terzaghi, 1943, and Terzaghi et al. 1996), 3) The rocks of the Pila Spi formation, locally include claystone layers (Fig. 6a) that can

Fig. 4. Road Cuts with well bedded, carbonate rocks of the Pila Spi Formation where bedding planes daylight in the slope face (Station No. 7)

- Installing of: 1) support elements such as rock bolts in the limestone beds of the Pila Spi Formation, which form daylighting slopes, in Section B C, 2) suitable steel dowels and concrete buttresses at selected locations in the First Sector, 3) digging horizontal drains in the slope of Section (A B) to reduce pore water pressure at specific locations, 4) erection of retaining walls between the slope and the road along the Second Sector. Spraying shotcrete along the slopes which are covered with soft rocks at specific locations.

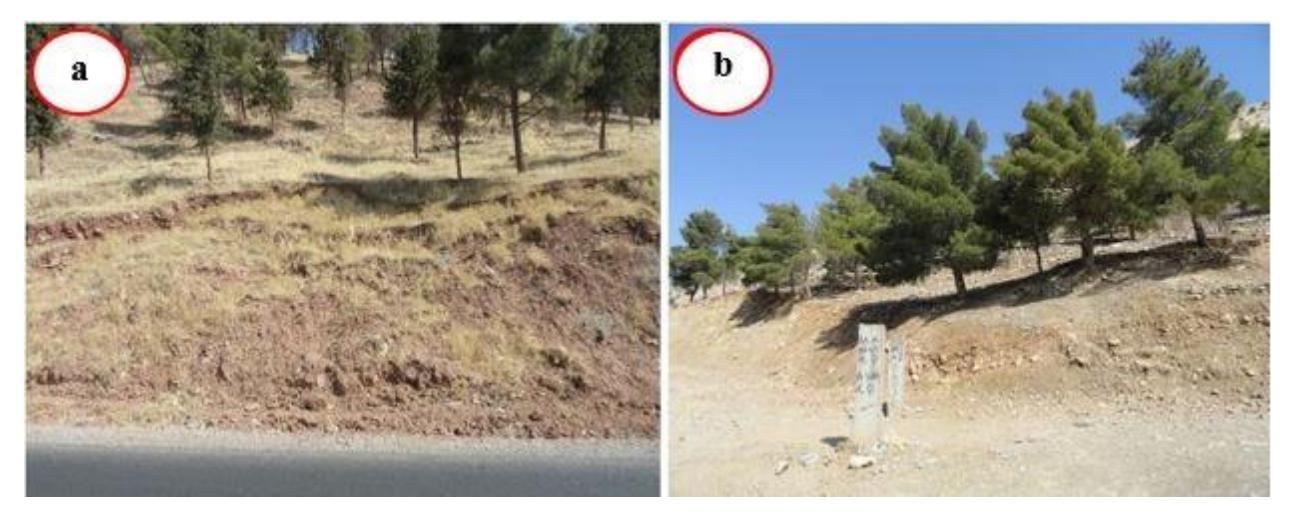
Fig. 5. Two unstable slopes in residual soils. 5a) Studied station No. 1, note the recent failure with the developed cliff in the crown area. 5b) Studied station No. 2, note the inclined trees

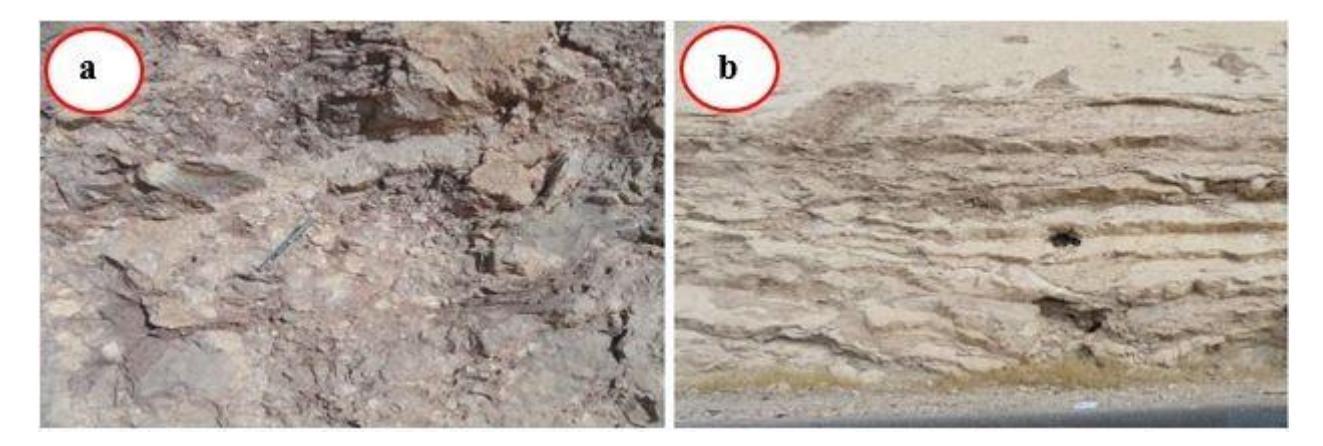
produce lubricated sliding surfaces, and karst cavities (Fig. 6b), which accelerates water penetration in the slope causing the failure.

Fig. 6. The Pila Spi Formation, 6.a) Reddish brown claystone, it acts as a lubricant surface for sliding after being oversaturated, 6.b) Karst cavities, which accelerate water penetration

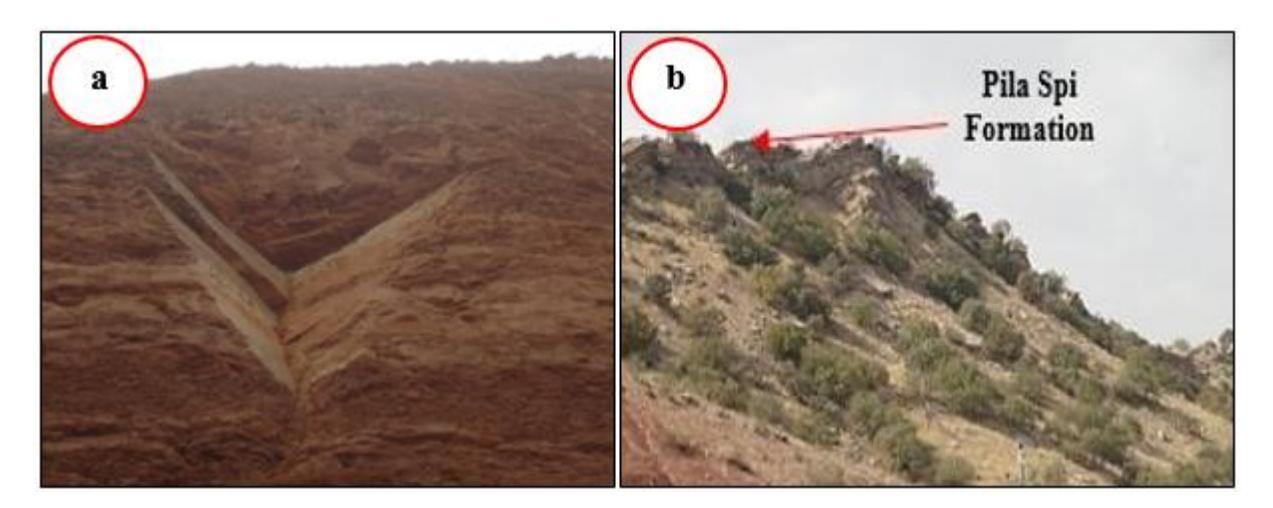
Section C – D includes studied stations No. 8 – 11 (Fig. 1). In this section, no sliding can occur along the main road cut. However, when the face of any road cut runs almost perpendicular to the slope of the main road cut; then sliding may occur (Fig. 7a). The main mass wasting, which occurs along the road is in the form of rock disintegration (Fig. 7a and 7b). This is attributed to: 1) The claystone beds within the Gercus Formation are thinly bedded and intensely jointed (Fig. 7a); therefore, these areas are prone to disintegrate; even though the road runs along slopes, which are opposite to the dip direction, 2) The directions of the road cuts and their slope angles intersect with the attitudes of the bedding and joint planes and form unstable slopes, and/ or prone areas for wedge failure (Fig. 7a), and 3) The anti-dip slope is capped by the carbonate rocks of the Pila Spi Formation forming hanging cliffs (Fig. 7b) because of the weathering of the soft rocks of the Gercus Formation, thus forming unstable slopes, which may exhibit toppling, sliding and occasionally rock fall. It should be noted that the local transportation agency has modified the road cut with a 30 m offset from the toe of the slope to the road. This will decrease the likelihood of a wedge failure which could produce a large landslide along the road cut.

Fig. 7a. The Gercus Formation, well bedded and intensely jointed claystone beds and wedge sliding (Studied station No. 10), Fig. 7b: Hanging cliffs formed by the carbonates of the Pila Spi Formation, overlying soft rocks of the Gercus Formation; forming prone areas for sliding, toppling and rock fall
