Slope Stability Analysis of Haibat Sultan Road Cut, Kurdistan Region, Iraq Using a Field Method

Abstract

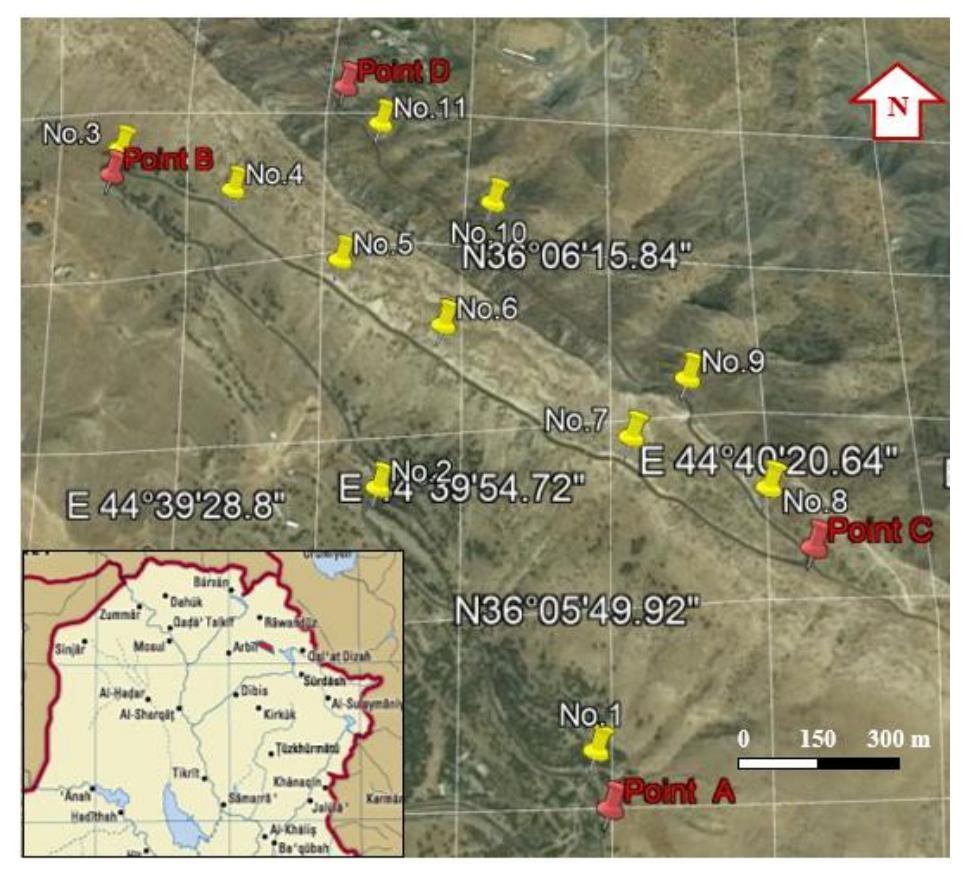
Fig. 1. Satellite image of the studied part of Haibat Sultan crossing road showing the studied stations with serial numbers, and three sections (parts) of the road. The red rectangle shows the location of the studied road at Iraq

Sections A – B and B – C include studied stations No. 1 – 7 (Fig. 1). The main reasons for the presence of landslides and potential areas for sliding are: 1) The majority of the road cuts are parallel to the bedding planes of the Pila Spi Formation, where the bedding planes daylight in the slope faces (Figs. 3 and 4), 2) Locally, claystone and/ or residual clayey soil form potential areas for sliding (Studied stations No. 1 and 2) (Fig. 5), especially when oversaturated by rain water, which will increase the pore water pressure. This will decrease the internal friction and cause sliding (Terzaghi, 1943, and Terzaghi et al. 1996), 3) The rocks of the Pila Spi formation, locally include claystone layers (Fig. 6a) that can

Section C – D includes studied stations No. 8 – 11 (Fig. 1). In this section, no sliding can occur along the main road cut. However, when the face of any road cut runs almost perpendicular to the slope of the main road cut; then sliding may occur (Fig. 7a). The main mass wasting, which occurs along the road is in the form of rock disintegration (Fig. 7a and 7b). This is attributed to: 1) The claystone beds within the Gercus Formation are thinly bedded and intensely jointed (Fig. 7a); therefore, these areas are prone to disintegrate; even though the road runs along slopes, which are opposite to the dip direction, 2) The directions of the road cuts and their slope angles intersect with the attitudes of the bedding and joint planes and form unstable slopes, and/ or prone areas for wedge failure (Fig. 7a), and 3) The anti-dip slope is capped by the carbonate rocks of the Pila Spi Formation forming hanging cliffs (Fig. 7b) because of the weathering of the soft rocks of the Gercus Formation, thus forming unstable slopes, which may exhibit toppling, sliding and occasionally rock fall. It should be noted that the local transportation agency has modified the road cut with a 30 m offset from the toe of the slope to the road. This will decrease the likelihood of a wedge failure which could produce a large landslide along the road cut.

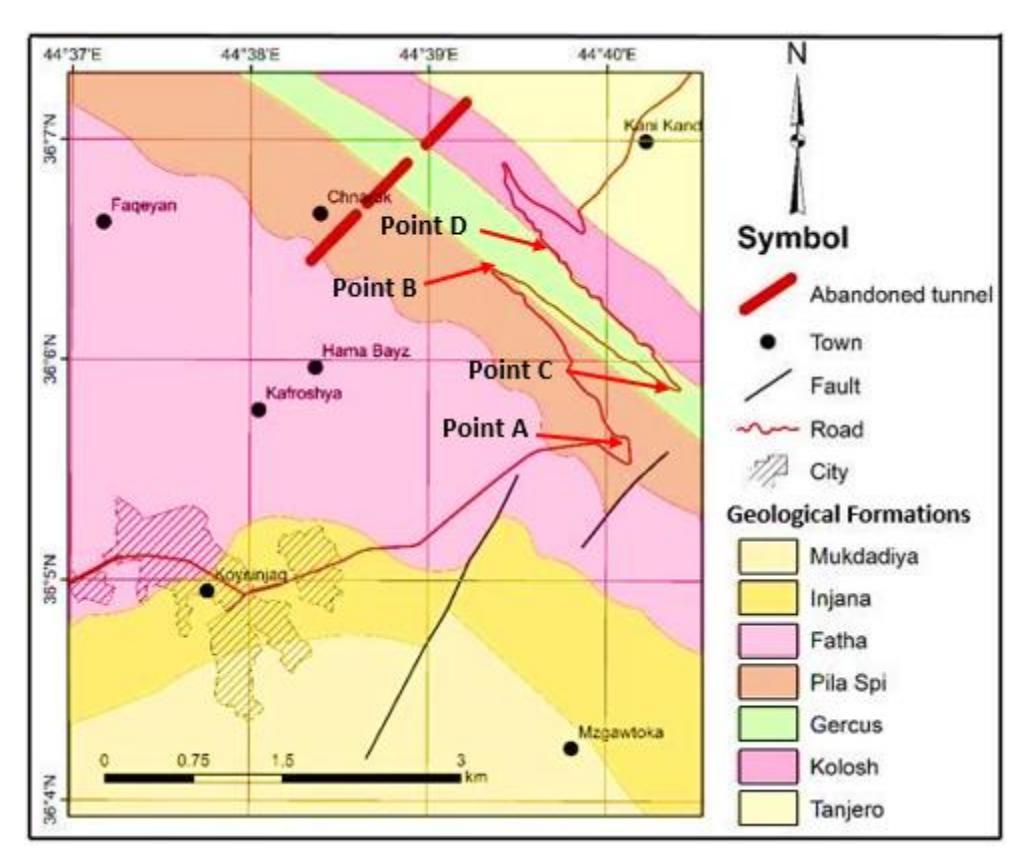
Fig. 2. Geological Map of the study area (After Sissakian and Fouad, 2015)

The differences in the instability problems between the mentioned three sections are attributed to: 1) The slopes in the first sector are dip slopes, whereas in the second sector are anti-dip slopes, 2) The exposed formations in the first sector are the Fatha and Pila Spi formations (Fig. 2). The former consists of thick red claystone with very thin limestone and gypsum. The latter consists of dolomite, dolomitic limestone, well bedded and hard to very hard; however, the former covers only the first 200 m; whereas the latter covers the remaining portion of the sector, which is about 1700 m. In the second sector, the exposed formation is Gercus (Fig. 2). The formation consists of thinly, well bedded, reddish brown claystone with thin horizons of limestone. The formation covers the majority of this part.
